**Appendix G PRE-DEMOLITION ASBESTOS AND LEAD-BASED  
PAINT SURVEY**

**Reference: Pre-Demolition Asbestos and Lead-Based Paint Survey**

Biogas Renewable Generation Project  
7721 N Figueroa Street, Los Angeles, CA 90041  
Stantec Project no.: 2057123300

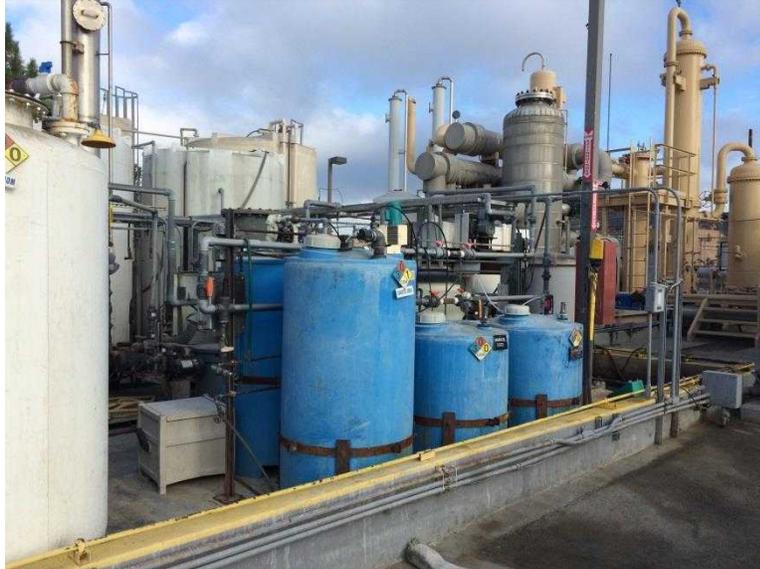
**PHOTO No. 1, September 14, 2015**

View of tanks at condensate treatment area.

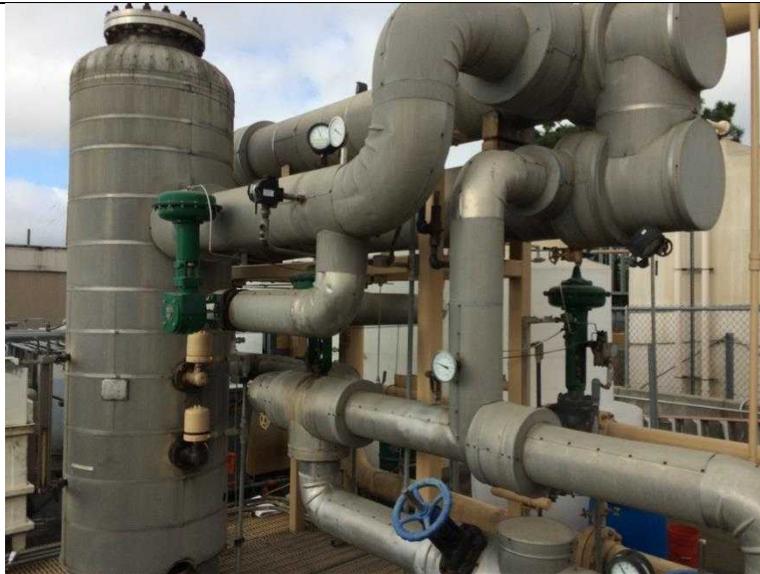
**PHOTO No. 2, September 14, 2015**

View of refrigeration exchange skid.

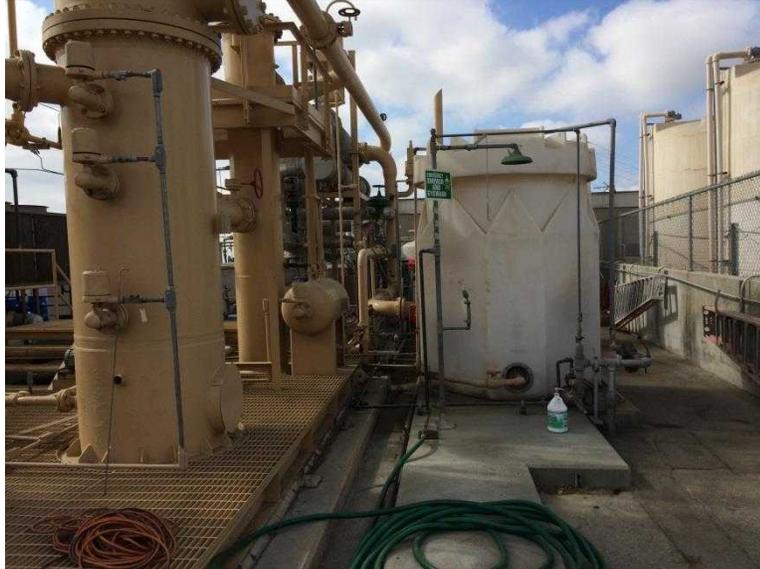
**PHOTO No. 3, September 14, 2015**

View of scrubber skid.

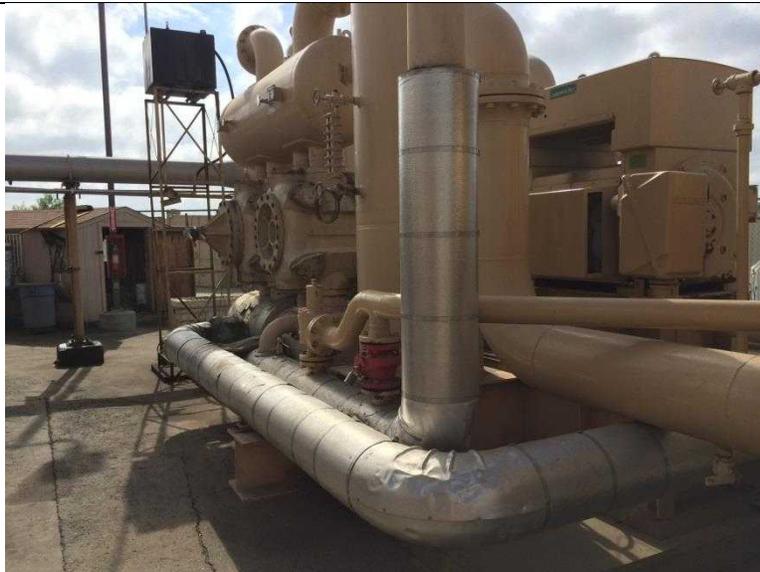
**PHOTO No. 4, September 14, 2015**

View of north gas compressor.

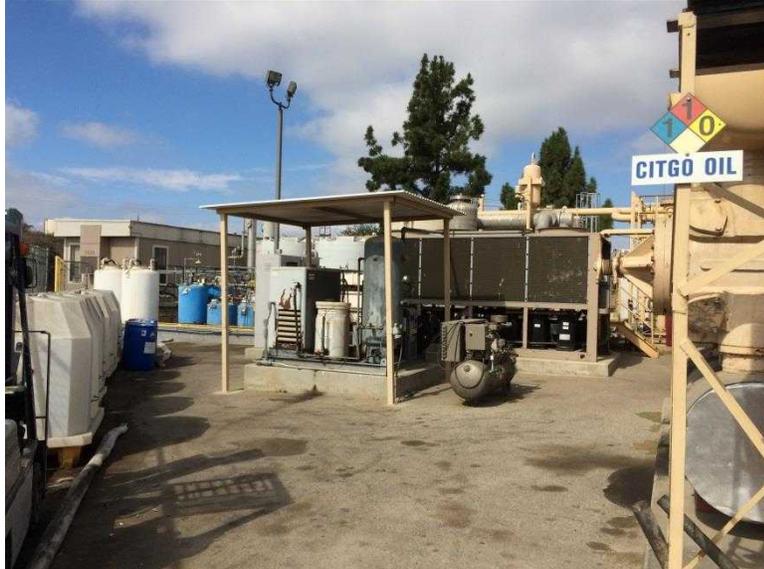
**PHOTO No. 5, September 14, 2015**

View of air compressors.

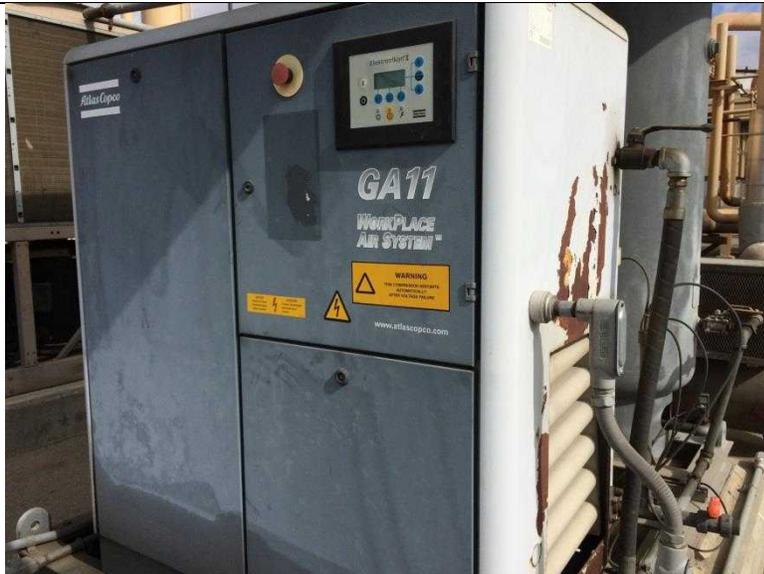
**PHOTO No. 6, September 14, 2015**

View of air compressor panel.
