# City of Glendale Parking Structure Evaluation Report

Document: 418001-00002-ST-REP-0001

Date: September 2019

**Worley Group Inc.**  
2675 Morgantown Rd.  
Reading, PA 19607  
USA  
Telephone: +1 610 855 2000  
[www.worley.com](http://www.worley.com)  
COA # 8777

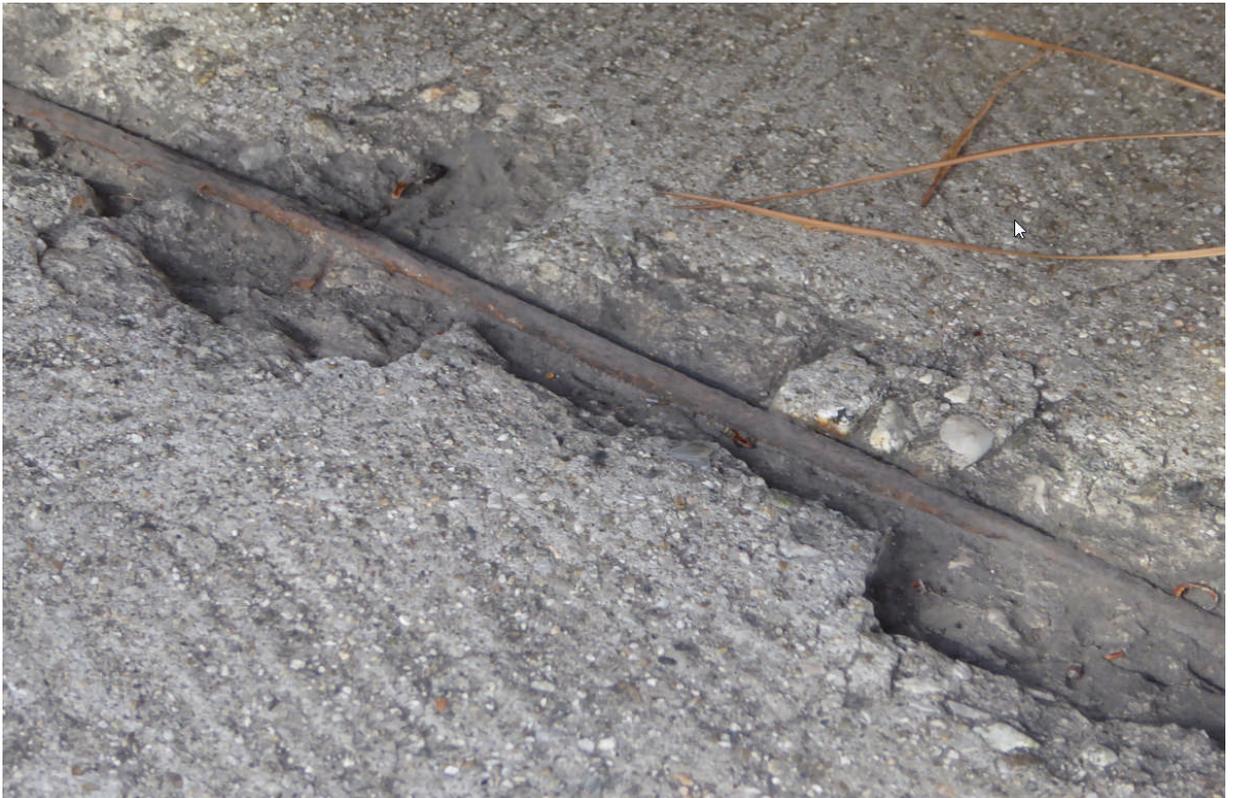
- G. There are visible degradations and local failures of existing parking structure elements at various locations. Some of these are captured during field visit and are shown on Figures 9 thru 14 in Appendix 1. All necessary repairs to the existing structure should be completed before any new loads from solar panel installations are introduced.

**Figure 9: Local Degradation of Concrete Floor**

- F. Repairs to the existing structure at the locations identified in Section 4 should be completed before installation of new solar panels and associated accessories on the roof.

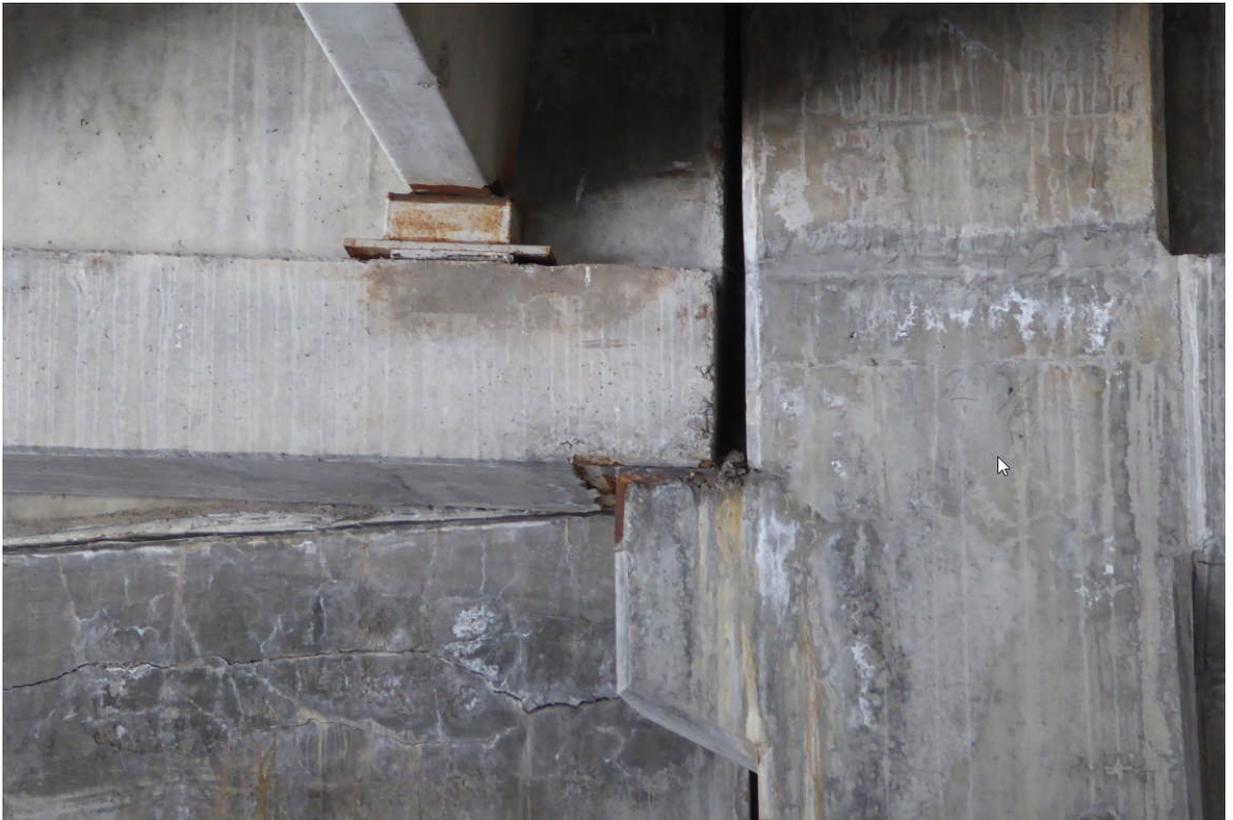
**Figure 10: Local Degradation of Concrete Girder Support**

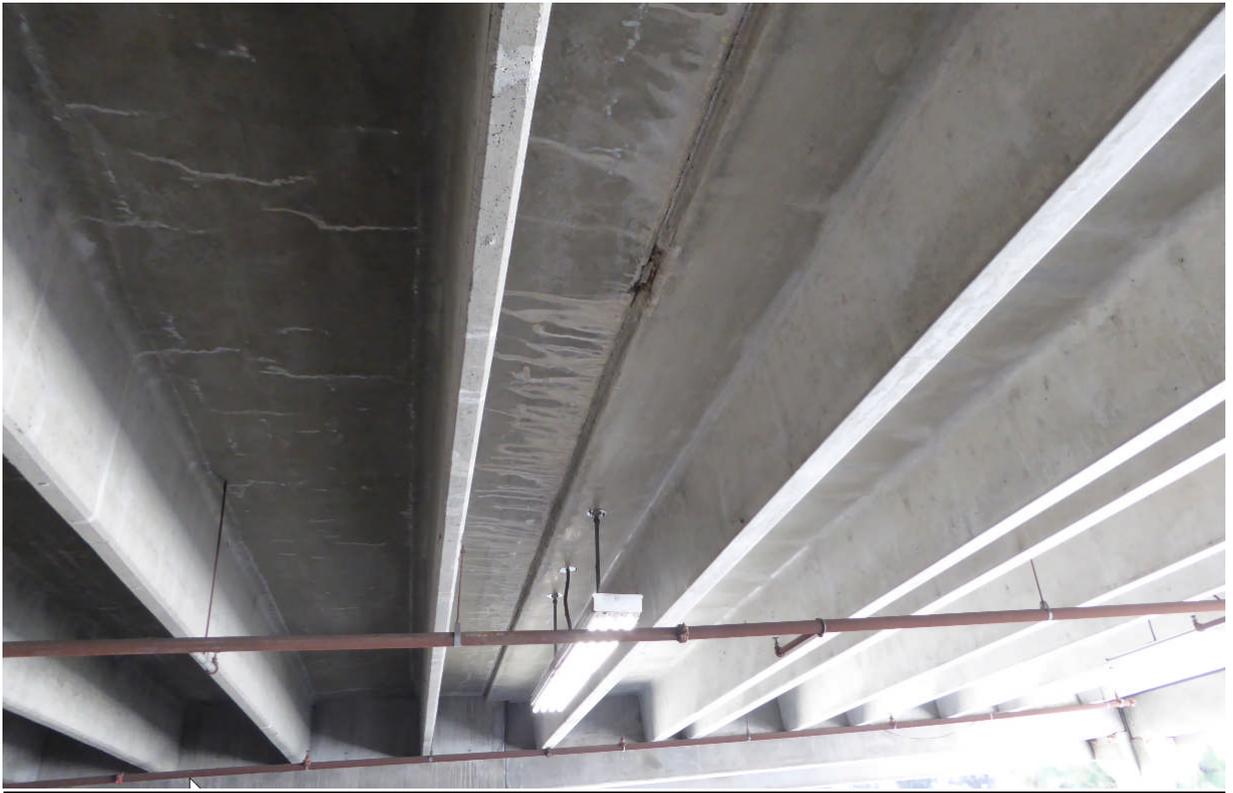
**Figure 11: Local Degradation of Double T Beams**

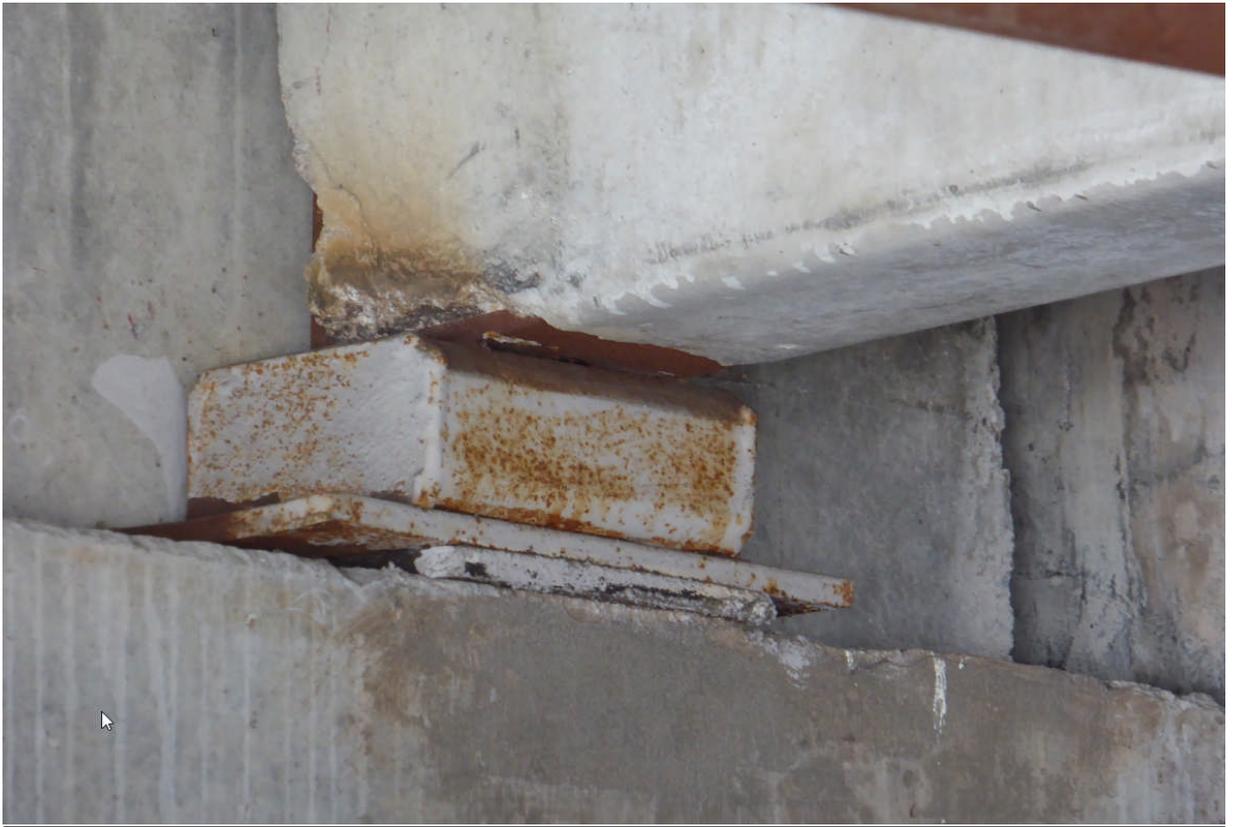
**Figure 12: Local Degradation of Double T Beam Support**

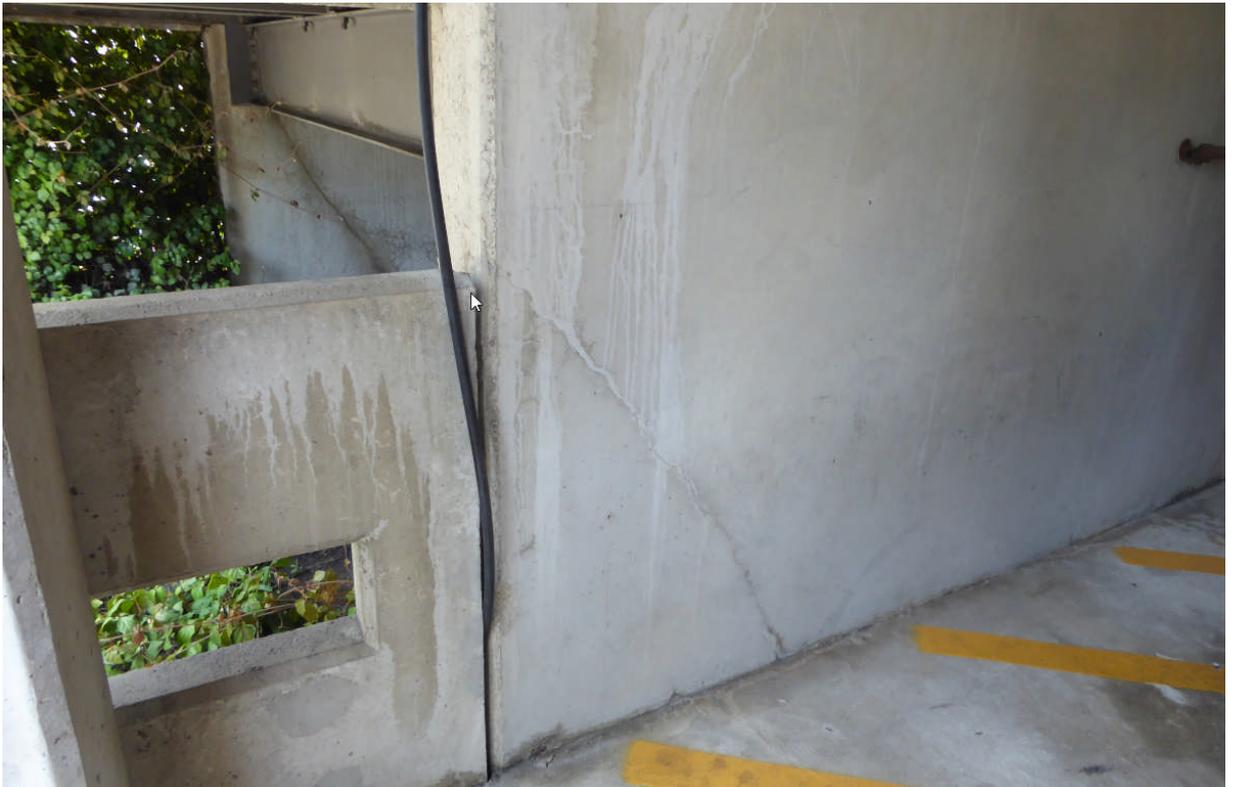
**Figure 13: Local Degradation of Concrete Shear Wall**

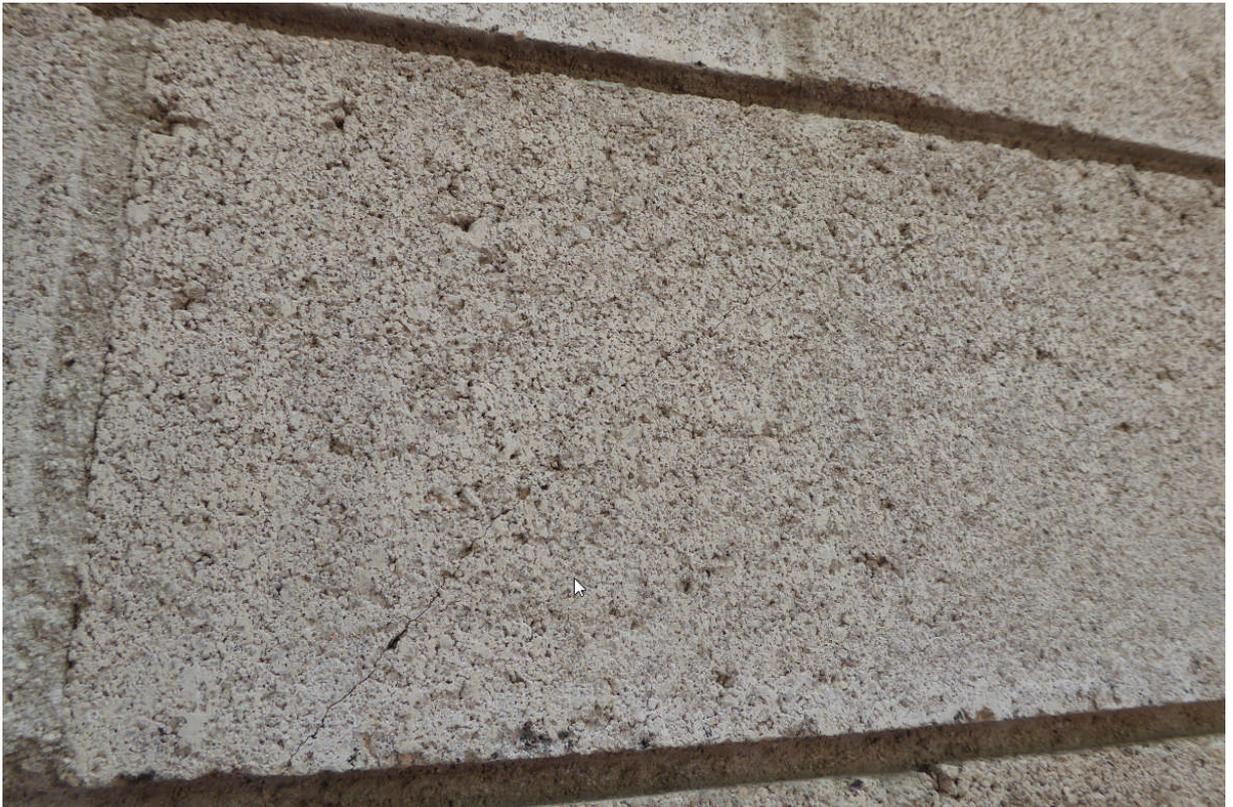
**Figure 14: Local Degradation of Masonry Shear Wall**

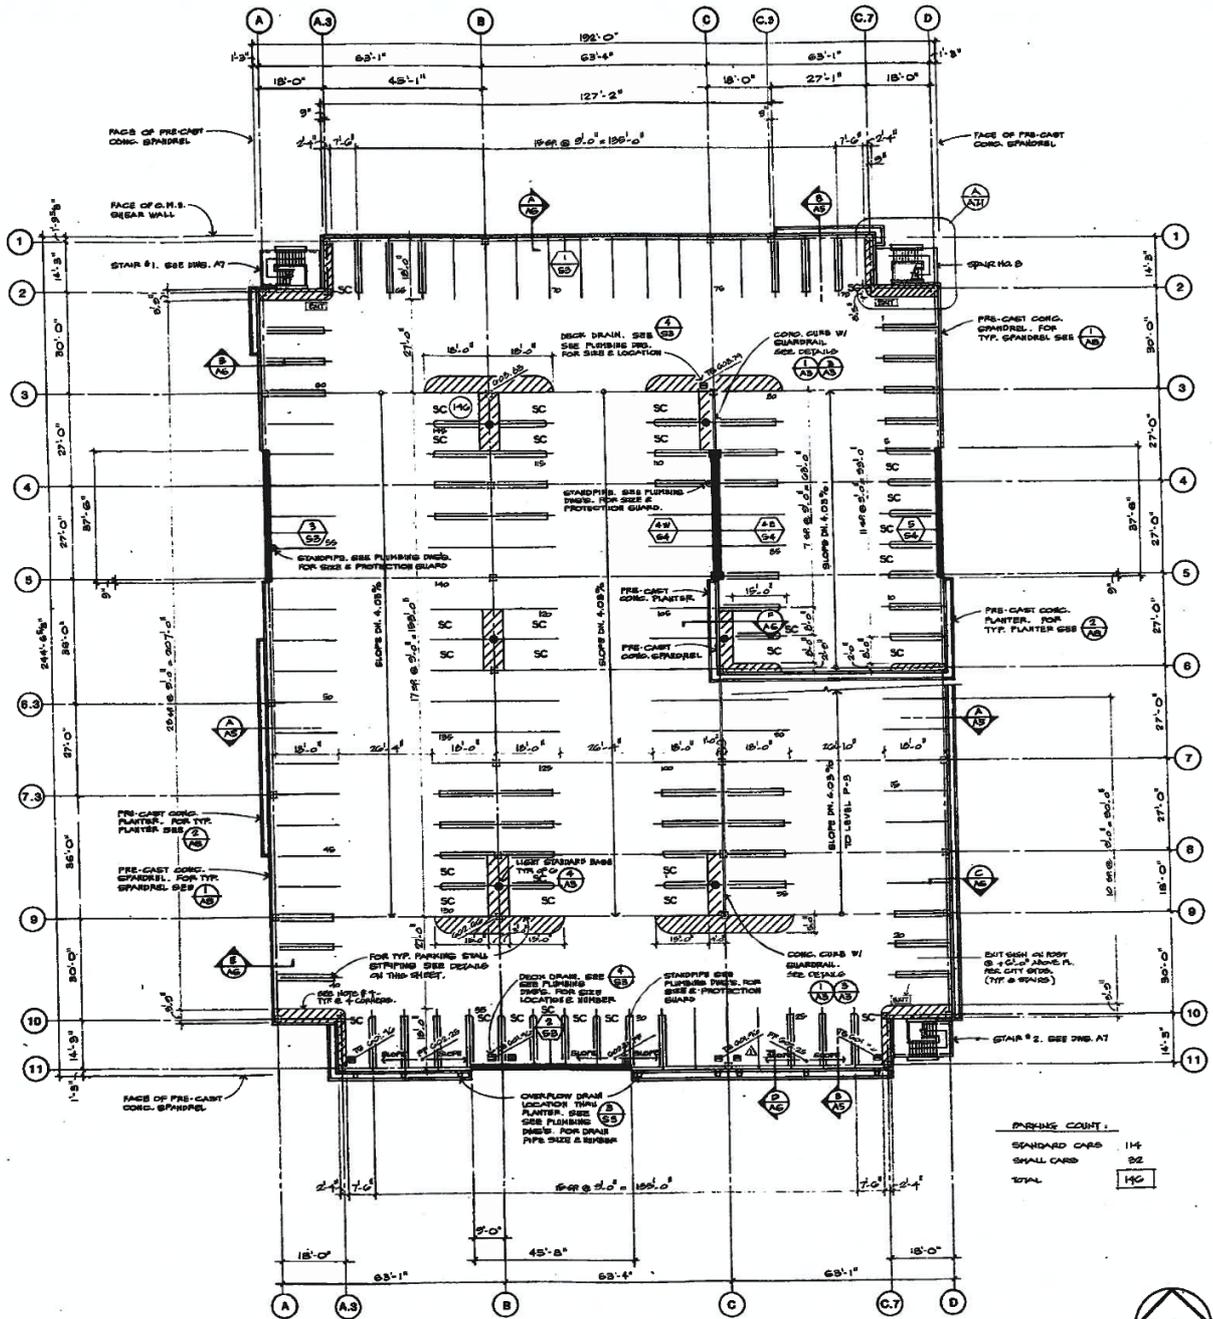
**ROOF P-4 LEVEL PARKING PLAN**

- B. Existing external column footings on Grid A (specifically Grid A-6.3 and A-7.3) are at or above their design capacities for the current loading condition. No additional gravity load should be placed on top of or at locations adjacent to these columns. See existing Roof Plan in Appendix 3 for Building Grid locations.

- C. Existing internal column footings on Grid B (specifically Grid B-3, B-4, B-5, B-6 and B-7) are close to their design capacities. No additional gravity loads are recommended to be placed on top of or at locations adjacent to these columns. See existing Roof Plan in Appendix 3 for Building Grid locations.

- A. Any addition of future gravity load due to solar panel installation on the roof level should be located on top of the shear walls on Building Grids 1, 11, A, C and D. In addition, top of the columns located at Building Grids D6, C7, D7, B8, B9, C8, C9, D8 and D9 can be utilized for attaching new installations. See existing Roof Plan in Appendix 3 for Building Grid locations.
