State of California The Resources Agency
DEPARTMENT OF PARKS AND RECREATION
PRIMARY RECORD

Page 1 of 1 *Resource Name or # (Assigned by recorder) 1709 Ben Lomond Dr.

*P10. Survey Type: (Describe)
N. Cumberland Heights Reconnaissance Survey (Update of 2004 Survey)

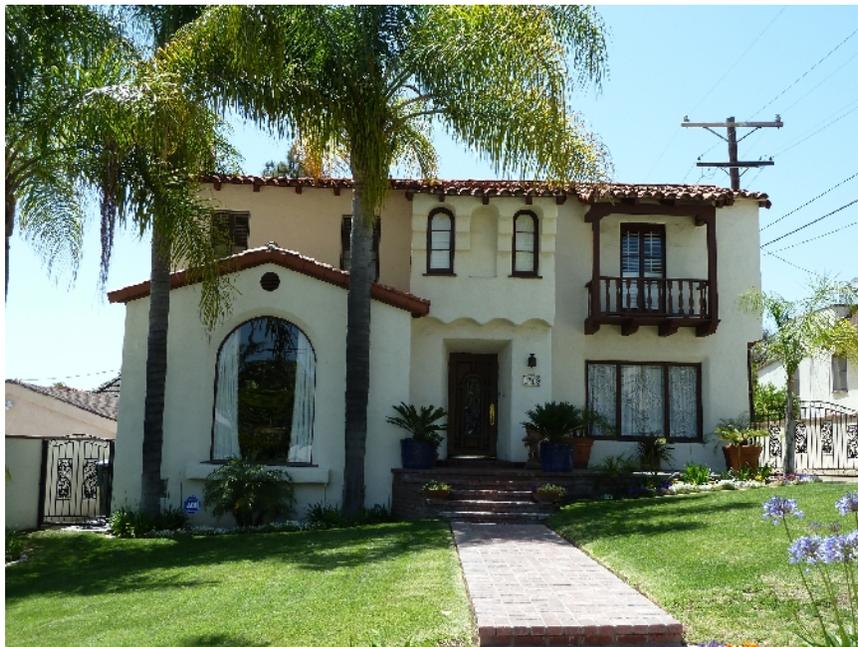
P5a. Photograph or Drawing (Photograph required for buildings, structures, and objects.)

This is a two-story single-family residence designed in the Spanish Colonial Revival style, constructed in 1928. It is rectangular in plan with flat roof to rear, pitched roof at front elevation and projecting first story wing with front gable roof all clad in clay tile. The walls are clad in smooth stucco. The primary façade is asymmetrical. The windows are fixed and casement arched rectangular divided-lights constructed of wood; the door is recessed. Character-defining features include a projecting balcony with wood posts and balustrade, exposed rafter tails, arched fixed picture window, stepped corbels under roofline, and arched corbels under overhanging second story. Landscaping consists of lawn, brick walkway and stairs leading to main entrance, and palm trees. The overall integrity of the building is excellent.

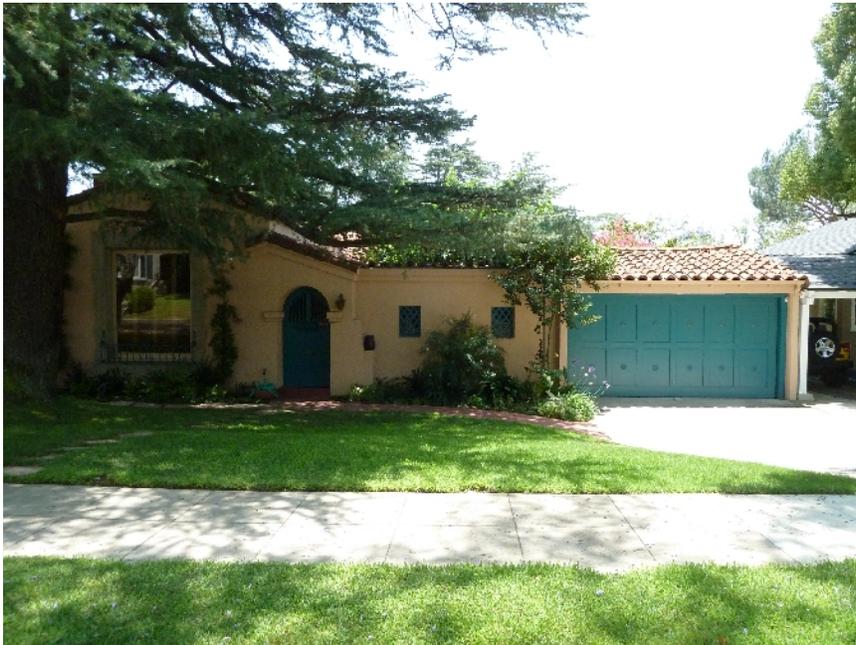
This is a single-family one-story residence designed in the Spanish Colonial Revival style, constructed in 1932. It is L-shaped in plan with a low-pitched cross-gable roof, clad in clay tile. The primary façade is asymmetrical. The walls are clad with smooth stucco. Windows include a large picture window with decorative iron grille work and rusticated stone surround and two fixed diamond-shaped openings. The double vertical door exhibits molded wood panels below a curved row of turned spindles. Character-defining features include projecting stepped arched entry portal with two projecting decorative moldings, attached garage with paneled door, exposed rafter tails and narrow molded frieze detail, and two decorative open work wood recessed window grilles. Landscaping consists of large pine tree, lawn, irregular stepping stone pathway, and planting areas by structure. The overall integrity of the building is good to excellent.

P5b. Description of Photo: (view, date, accession #) _____
7/6/2011

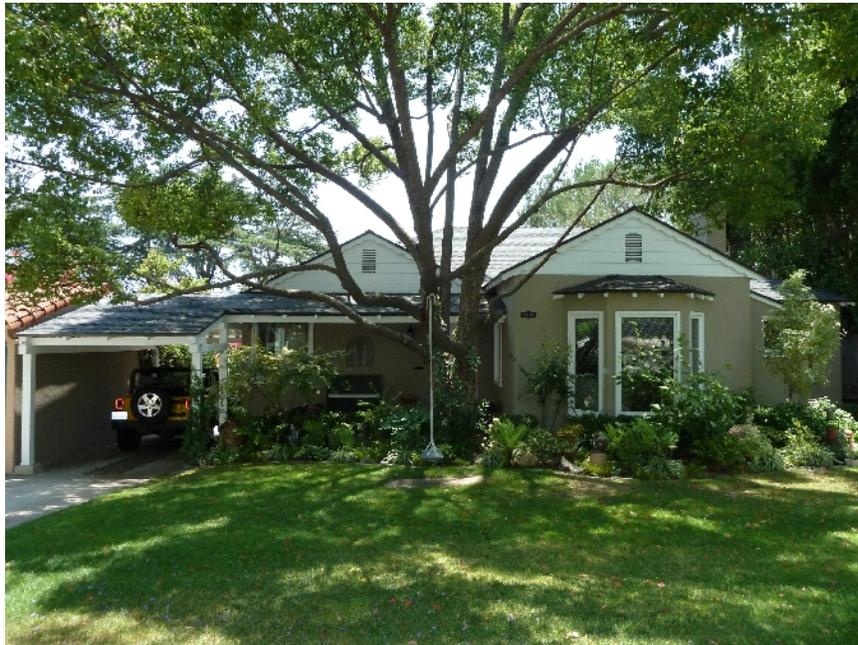
P5a. Photograph or Drawing (Photograph required for buildings, structures, and objects.)

This is a one-story single-family residence designed in the Minimal Traditional style, constructed in 1938. It is irregular in plan with a cross-gable and hip roof, clad in asphalt shingles. The primary façade is asymmetrical. The walls are clad with smooth stucco with decorated verge board on the primary gable and one pediment of horizontal wood-lap siding. The windows include a prominent three-sided bay window with fixed diamond-pane leaded sashes beneath a shed roof hood. Other windows are wood casement or metal sliders with one small stained glass bath window. The main entry features a covered front porch with a molded paneled door that features a small medallion on lower panel. Character-defining features include a brick chimney with small band of brick trim and a Porte Cochere with shed roof. Landscape consists of a lawn with planter beds set in front of low hedge with large old growth tree, Australian fern and smaller plants, and annuals. The overall integrity of this building is good.

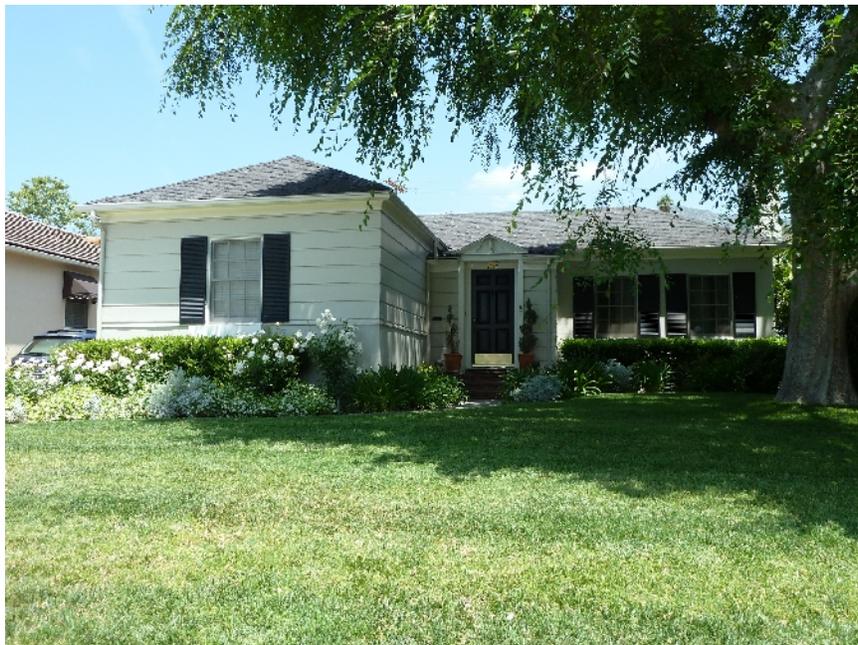
P5a. Photograph or Drawing (Photograph required for buildings, structures, and objects.)

This is a one-story single-family residence designed in the Minimal Traditional style, constructed in 1937. It is L-shaped in plan with a hipped roof, clad in asphalt shingles. The walls are clad in smooth stucco with accents of wood-lap. The primary façade is asymmetrical. The windows are double-hung divided-lights constructed of wood. Character-defining features are decorative wooden shutters, horizontal wood-lap on top half of projecting wing, and door with pediment outlined with wood-lap. Alterations include façade window replacement in 1995. Landscaping consists of a mature tree at the edge of the front lawn. The overall integrity of the building is good.

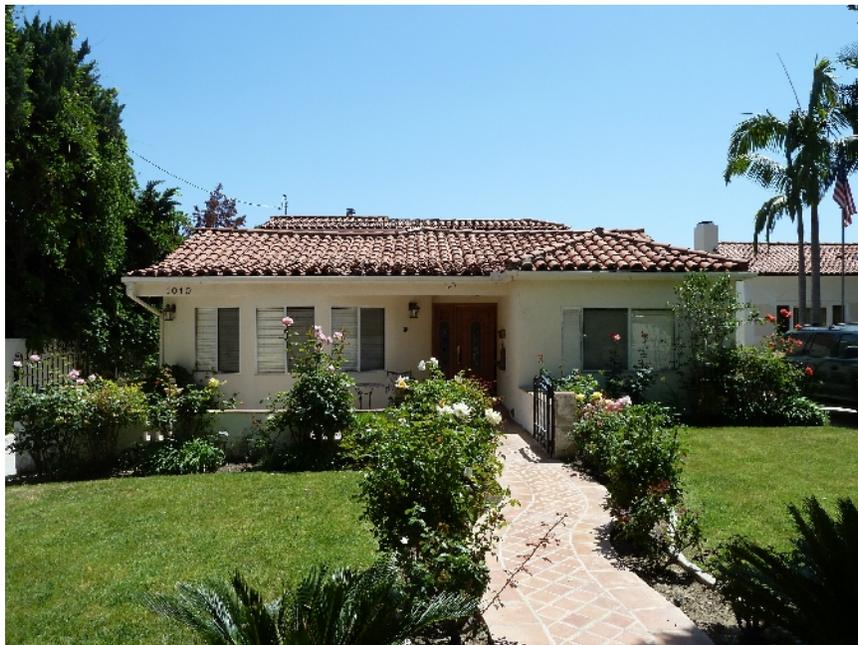
P5a. Photograph or Drawing (Photograph required for buildings, structures, and objects.)

This is a single-family residence and a one-story residence with a two-story rear addition designed in the Spanish Colonial Revival style, constructed in 1938. It is rectangular in plan with a low-pitched hipped and gable roof, clad in clay tile. The walls are clad with smooth stucco. The façade is asymmetrical. The windows are non-original vinyl, horizontal-sliding and the non-original door is flanked by a stained glass side-light on one side. Character-defining features are the tiled roof and an exterior half height walled courtyard with fountain in front. Alterations include a two-story side-gable addition at the rear of the residence, a two-stall garage with a flat tiled roof, vinyl windows at the rear of the property, and a wrought iron gate. Landscaping consists of a tiled walkway that cuts through a flat lawn at an angle with a wrought iron gate leading into a half height stucco walled courtyard, rosebushes and low plants surround the structure. The overall integrity of the building is poor.

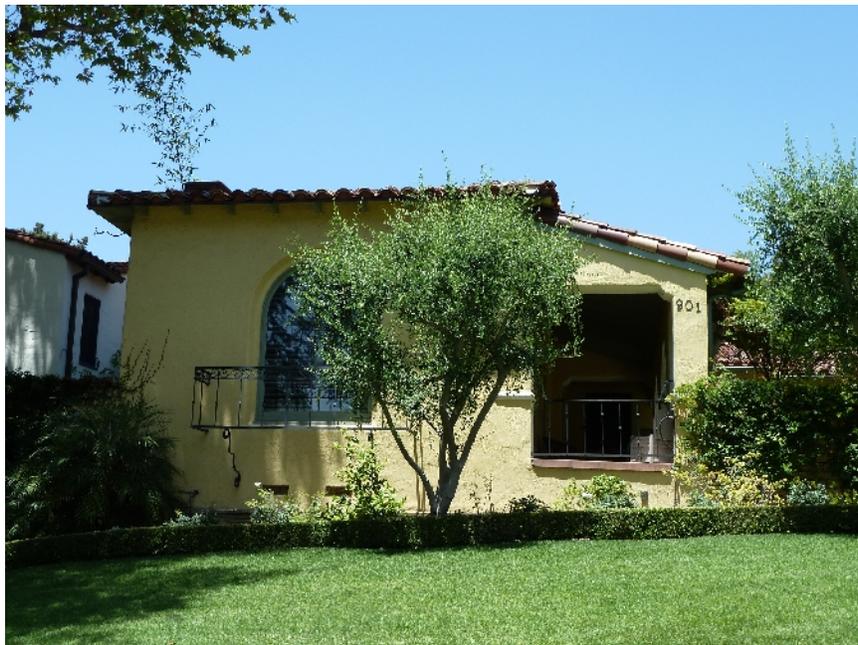
P5a. Photograph or Drawing (Photograph required for buildings, structures, and objects.)

This is a one-story single-family residence, on a corner lot with two street facades, designed in the Spanish Colonial Revival style, constructed in 1933. It is L-shaped in plan with a low-pitched cross-gable and flat roof, clad in clay tile. The walls are clad in smooth stucco with stone accents on the foundation. The primary façade is asymmetrical. The windows are primarily divided-light casements accented by several fixed and arched windows, all constructed of wood. Character-defining features are decorative iron eave brackets, exposed rafter tails, a covered front porch with arcaded openings, a half height brick wall enclosing the front courtyard area, a half height stucco wall enclosing the side courtyard, two chimneys with decorative caps, and decorative iron work on the patio railings and entrance gate. Alterations include a new brick retaining wall enclosing the front courtyard and a side addition consistent with the architecture of the main house. Landscaping consists of lush wall vines and fledgling trees and a stone step walkway to the entrance gate from the sidewalk. The overall integrity of the building is good.

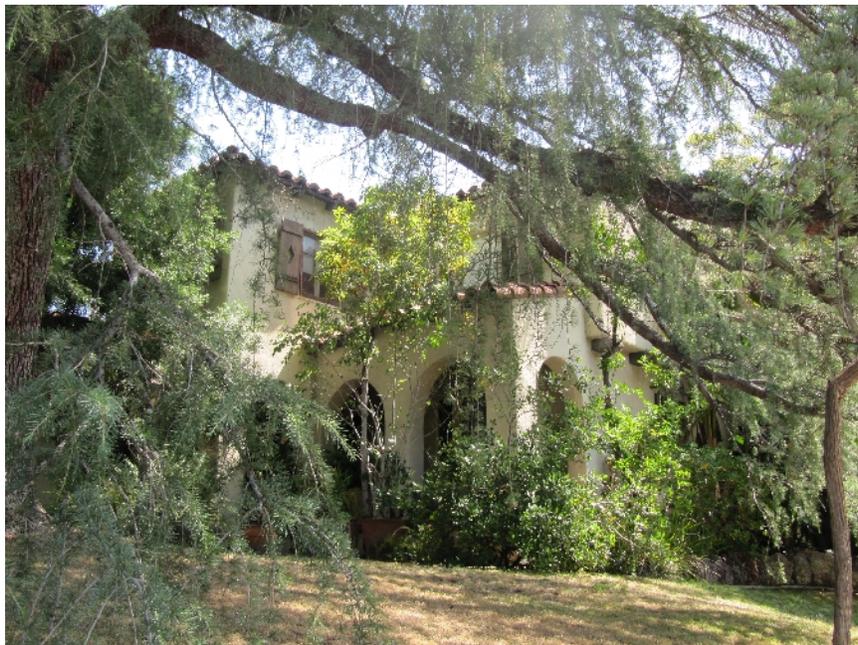
P5a. Photograph or Drawing (Photograph required for buildings, structures, and objects.)

This is a two-story single-family residence designed in the Spanish Colonial Revival style, constructed in 1931. It is rectangular in plan with a hipped and side gabled roof, clad in clay tile. The walls are clad in smooth stucco. The primary façade is asymmetrical. The windows are primarily divided-light casements, with some arched, fixed windows, all constructed in wood. Character-defining features are, wood shutters with diamond-shaped cut-outs, L-shaped porch, overhanging second story, exposed rafter tails, stained glass, and decorative iron work. No documented or observed alterations. Landscaping consists of extremely lush and heavy landscaping, stone walkway from sidewalk to the side entrance, and several mature trees including mature spruce and oak trees. The overall integrity of the building is excellent.

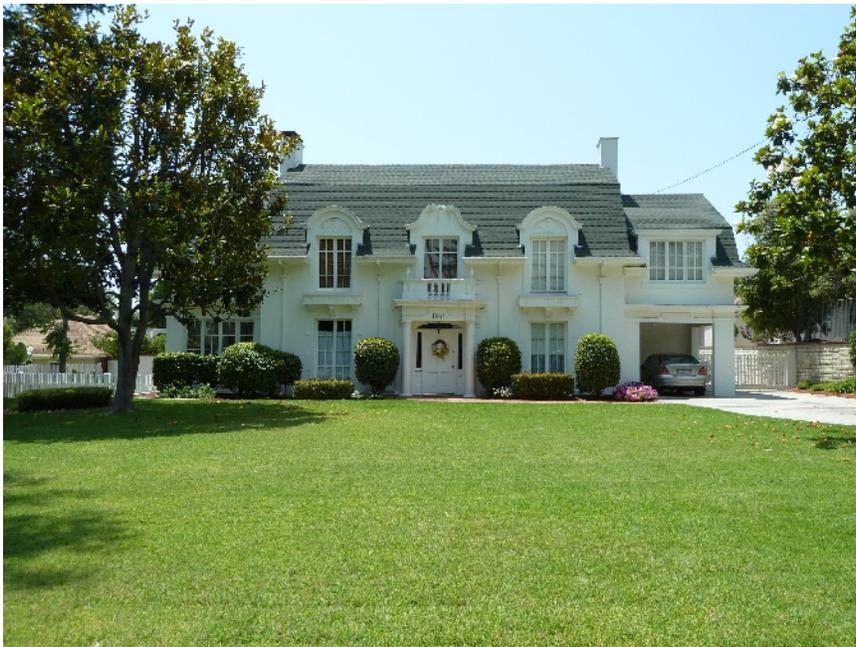
P5a. Photograph or Drawing (Photograph required for buildings, structures, and objects.)

This one-and-a-half-story single-family residence was constructed in 1922 and designed in the American Colonial Revival style with elements of the French Eclectic and Dutch Colonial styles. Rectangular in plan, the house features a side-gambrel roof with flared eaves, clad in asphalt shingles, and smooth stucco walls. The facade is symmetrical. The windows are casement and divided-light, constructed of wood, with wall dormers with arched and broken pediments above the second floor windows, and hoods with corbels over the first-story windows. The central front entryway has a eight-panel wood door with sidelights and transom, framed by an open porch with classical columns and topped with by a second floor balcony with balustrade. The character-defining features consist of the window and door decorative treatments, and flared eaves. Alterations include a second-story addition above the one-story south side portion of the original structure and a two-story addition to the north side of the original structure.

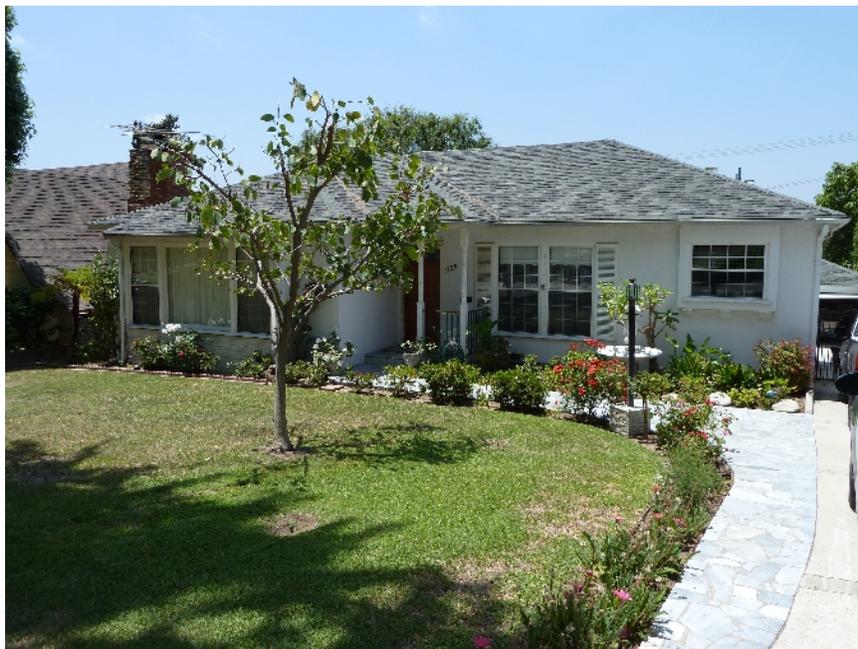
This is a one-story single-family residence designed in the Minimal Traditional style, constructed in 1949. It is square in plan with a low-pitch hipped roof, clad in asphalt shingles. The walls are clad in smooth stucco with stone accents on lower portion of façade. The primary façade is asymmetrical. The newer replacement windows are primarily double- or single-hung, vinyl with internal grids; the door is located on the central block façade, adjacent to the front wing. Character-defining features are fixed shutters, recessed entry porch defined by slender wood posts and metal railing, picture window with extended roof line as awning, multiple roof line defined by main hipped roof and two more defined hipped segments, and red brick chimney attached to the side of the house. Alterations include installation stone veneer cladding at the base. The overall integrity of the building is fair.

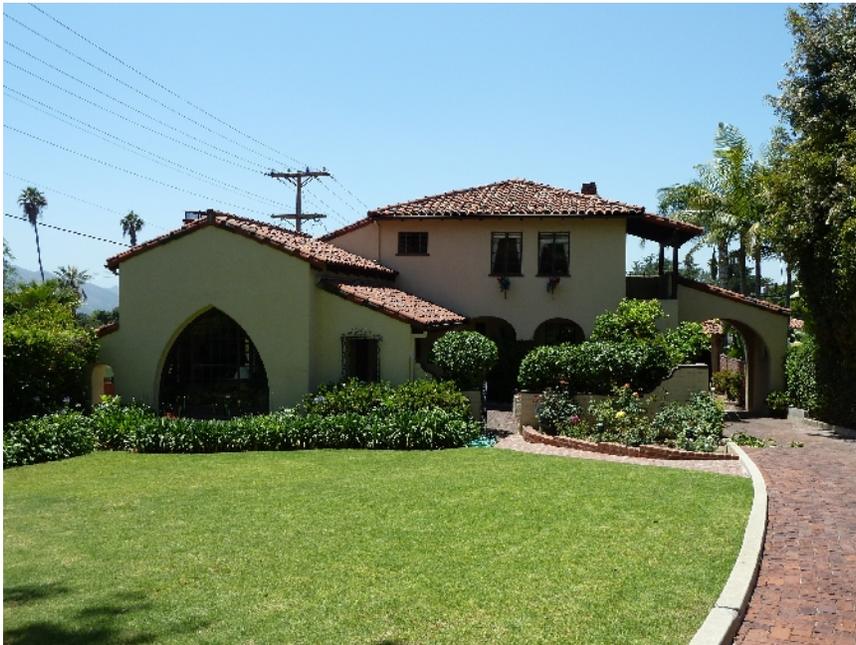
This is a two-story single-family residence designed in the Spanish Colonial Revival style, constructed in 1931. It is T-shape in plan with a hip roof and front-facing gable end clad in Spanish red clay tile. The primary façade is asymmetrical. The walls are clad with smooth stucco. The wood windows are casement and fixed constructed of wood and feature a pointed arch picture window on the front facing gable end. Portions of the arched windows are stained leaded glass. The main entry features an exterior courtyard enclosed by a half height wall and a covered porch with a trio of arched openings. Character-defining features include leaded stain glass, decorative iron work, a wing wall with an arched opening, a Porte Cochere, and a decorative wrought iron gate that opens to the exterior courtyard. Landscaping consists of the lawn, various plantings, a low brick planter with rose garden, a curved driveway paved with brick, and curved brick walkway leading to the main entry. The overall integrity of this building is excellent.

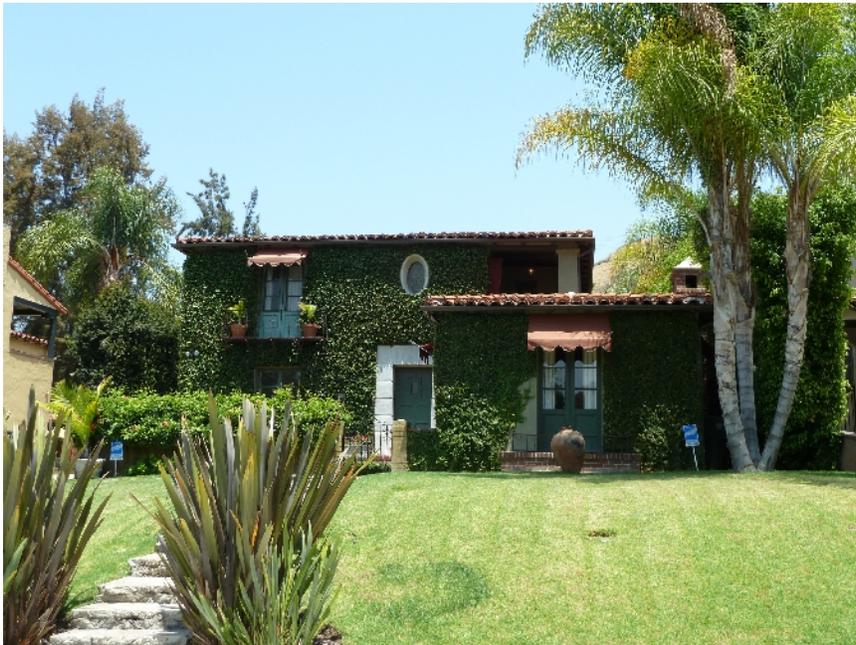
This is a two-story single-family residence designed in the Spanish Colonial Revival style with Mediterranean Revival influences, constructed in 1932. It is irregular in plan with a low-pitched hip roof, clad in clay tile. The walls are clad in smooth stucco. The primary façade is asymmetrical with an exterior courtyard. The windows are divided-light and casement constructed of wood. Character-defining features include a small stained glass oval window over door, exposed rafter tails, string course between floors, French doors, balconies, iron balustrade on windows and French double doors and around exterior courtyard, molded stone surrounding front door, and brick accent trim under front window and fireplace. The front façade is largely covered with vegetation. The overall integrity of the building is good.
