Phase I Environmental Site Assessment

Biogas Renewable Generation Project
3001 Scholl Canyon Road
Glendale, California 91206

May 16, 2019

Stantec Consulting Services Inc.
290 Conejo Ridge Avenue
Thousand Oaks, California 91361

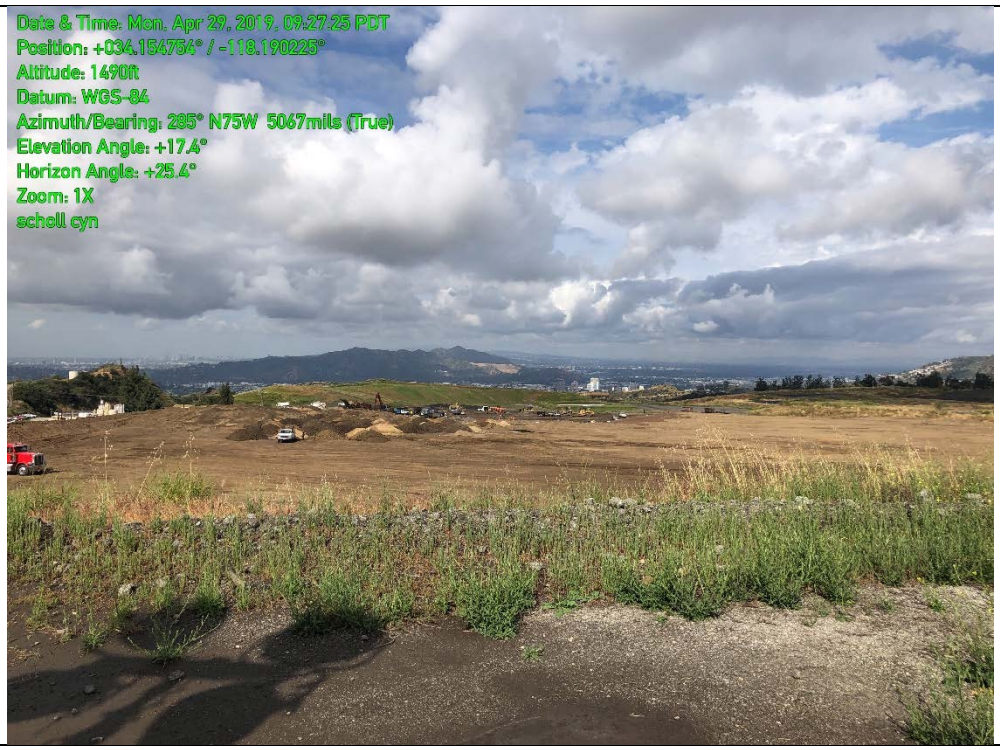
Photo #6 View of the landfill (not part of the Property) looking east-northeast.

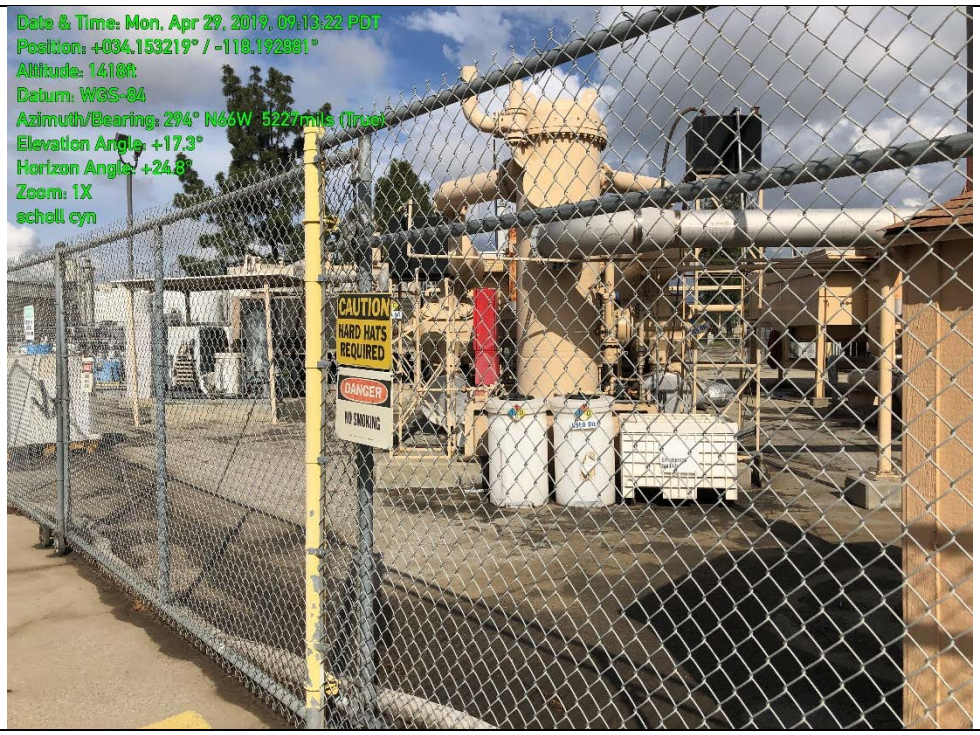
Photo #15 View of the used oil containers and emergency spill containers located south of the Property (no secondary containment noted).
